Morrison Creek Headwaters

Wetland and Tributary Mapping & Hydrological Study

March 2020

Current Environmental Ltd.

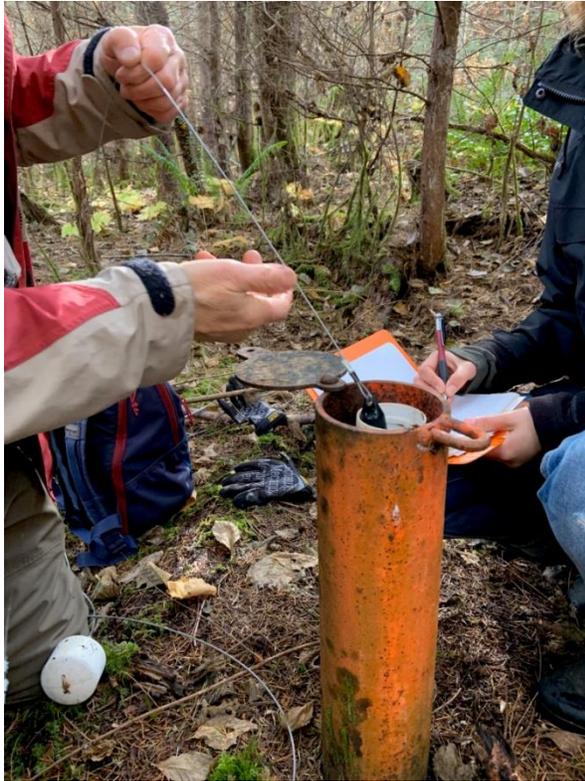
Photo 1. Retrieving data logger from groundwater well

Water level was continuously monitored using Solinst Leveloggers. Groundwater level and temperature was recorded in two existing drilled wells at approximately 4.5 m depth (**Photo 1**). For stream monitoring, level/discharge, data loggers were placed in stilling wells installed upstream of suitable “control” points, constrictions in channel cross-section which cause marked changes in water level with fluctuating stream flow (**Photo 2**).

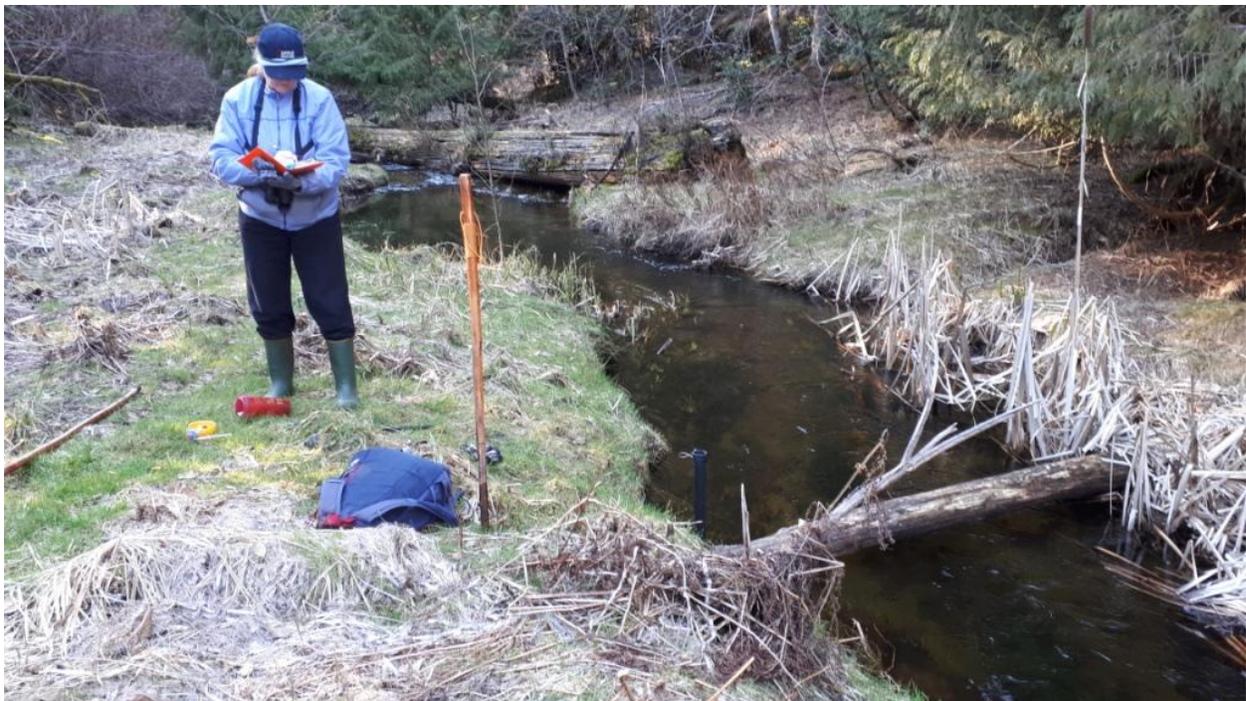
Photo 1: Levelogger is in stilling well (black pipe, lower centre), “control” point is at riffle/log, (behind top of stick). Upper mainstem site “Mainstem High”

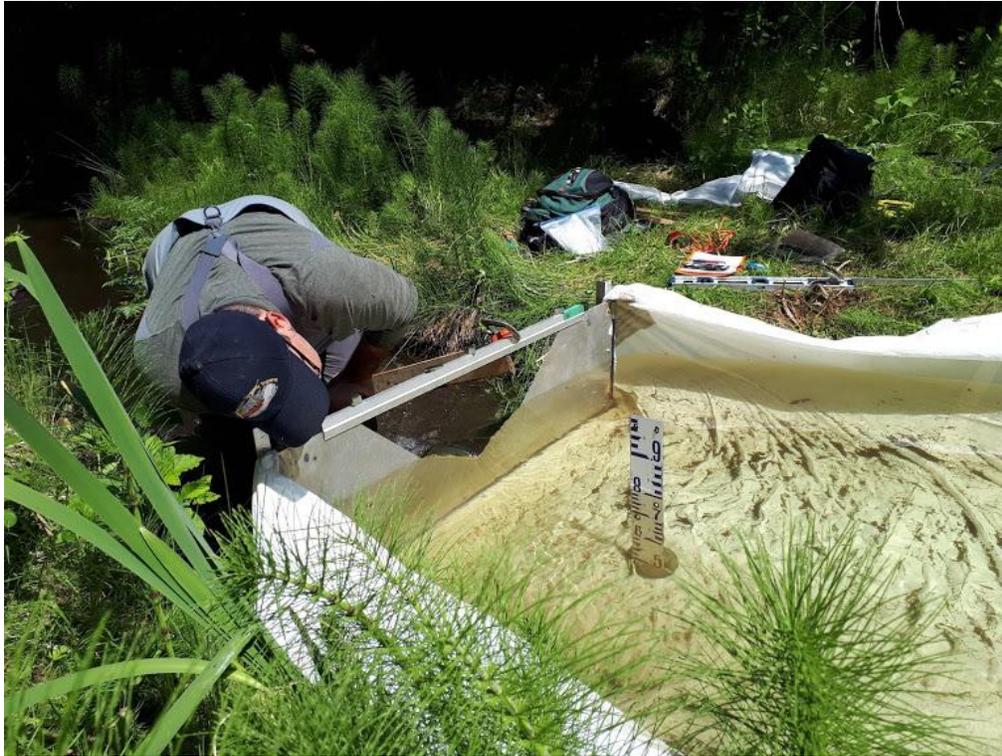
Photo 3: Using 90° V-Notch weir (integrated tarp style) in Trib ET

1. Portable V-notch weirs - Used for earlier measurements at all but one site, which was too large for this technique (**Photo 3 and 6**). A portable weir plate was installed temporarily at each site for each flow measurement. Water level was allowed to reach a stable level, which was used for calculating Q (discharge). We used online calculators from San Diego State University for all weir calculations. <http://ponce.sdsu.edu/onlineveenotch1.php> and <http://ponce.sdsu.edu/onlineveenotch2.php>. The weir plate was then removed and the site left in its natural state until the next measurement
2. Ott MF Pro – A computerized instrument using electromagnetic sensor technology, used for later readings at all sites. (**Photo 4 and 5**).

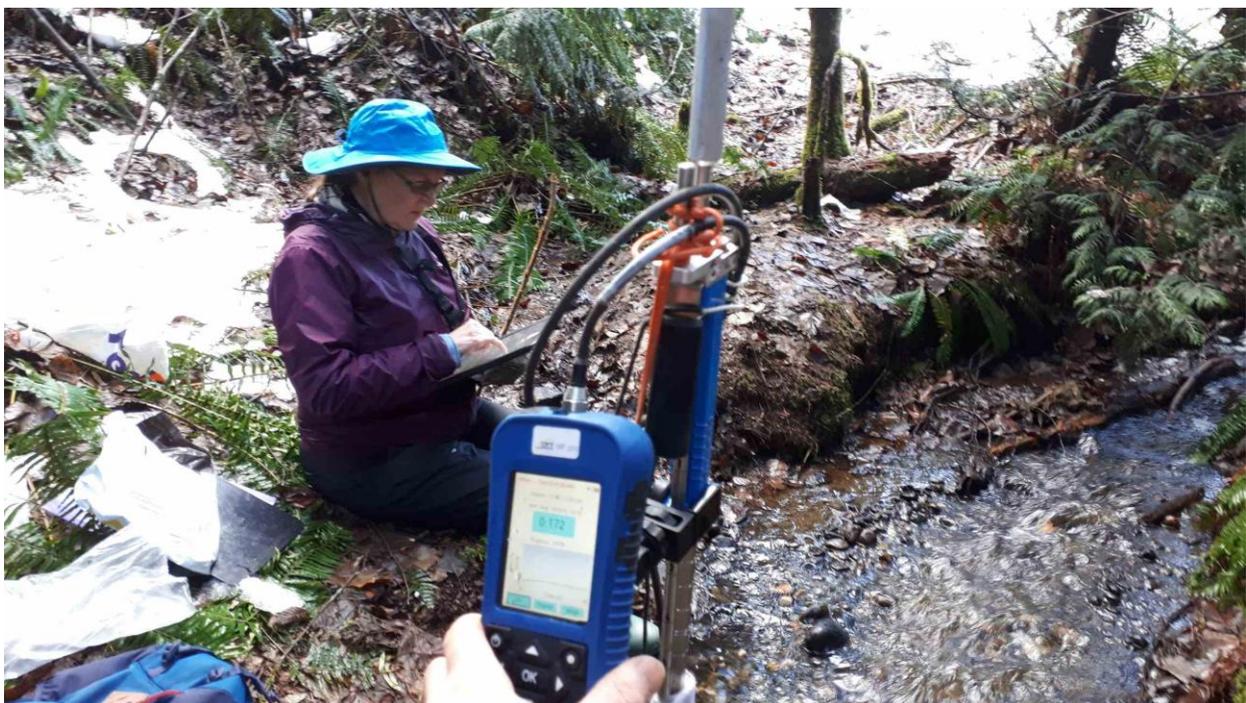
Photo 4: Flow transect using Ott MF Pro at Monkeyflower Trib

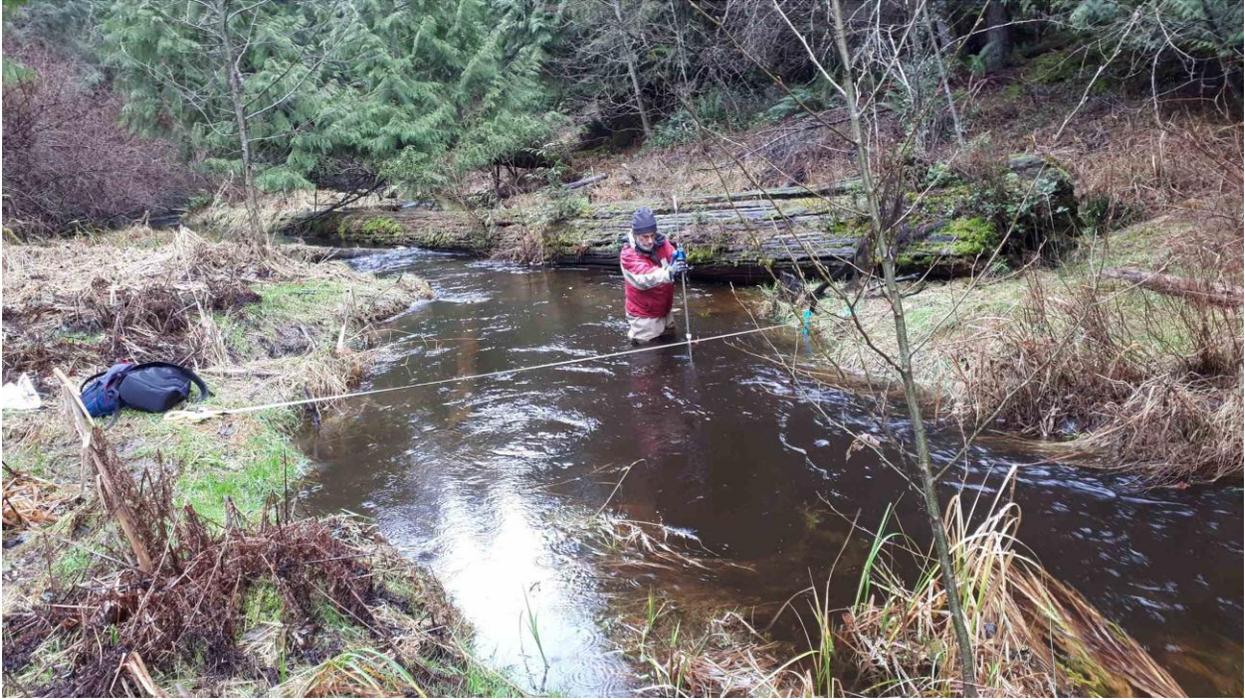
Photo 5: Flow transect at Mainstem High using Ott MF Pro during moderately high flow conditions

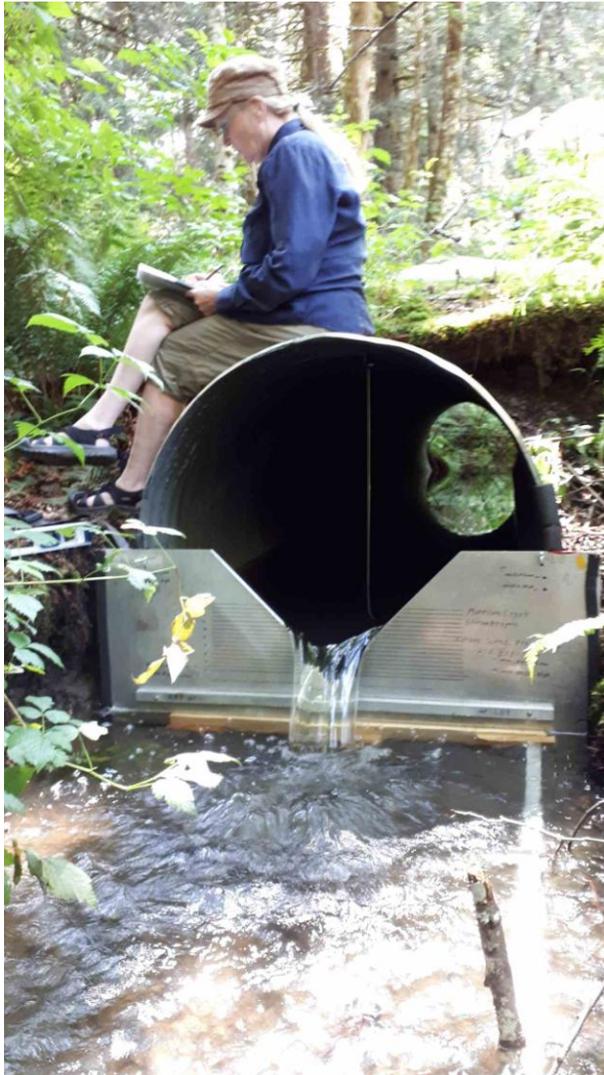
Photo 6: Using 90° V-Notch weir on Trib 8 culvert

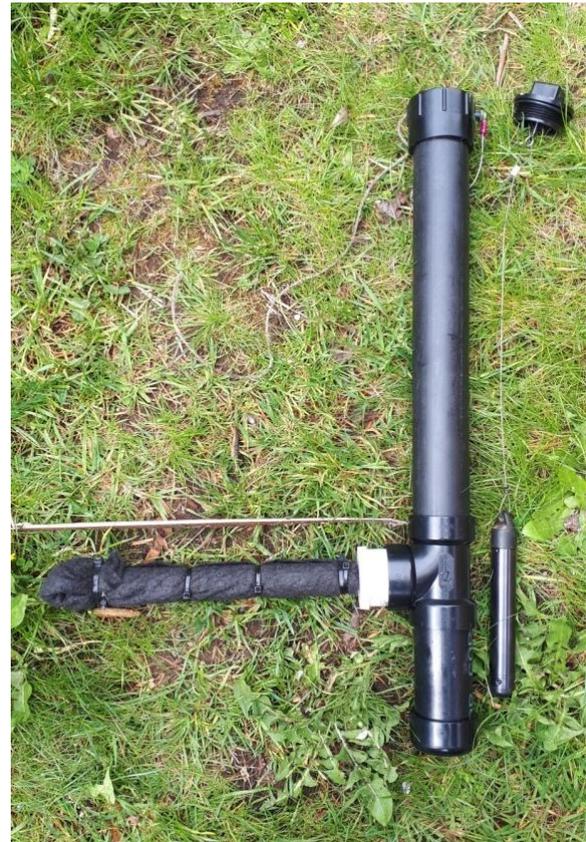
Photo 7: Typical stilling well/Levellogger setup, allowing use in very shallow water. Stick indicates typical streambed level. Note ½” lateral pipe wrapped in filter fabric to exclude sediment when lateral is buried. Short sump allows logger to be below streambed, but above sediment. Main pipe perforated with a series of 1/8” holes above streambed level.

Solinst Levelloggers were installed 1 ½" ABS pipe stilling wells. In shallow tributaries they were installed below streambed level as shown in **Photo 7**.

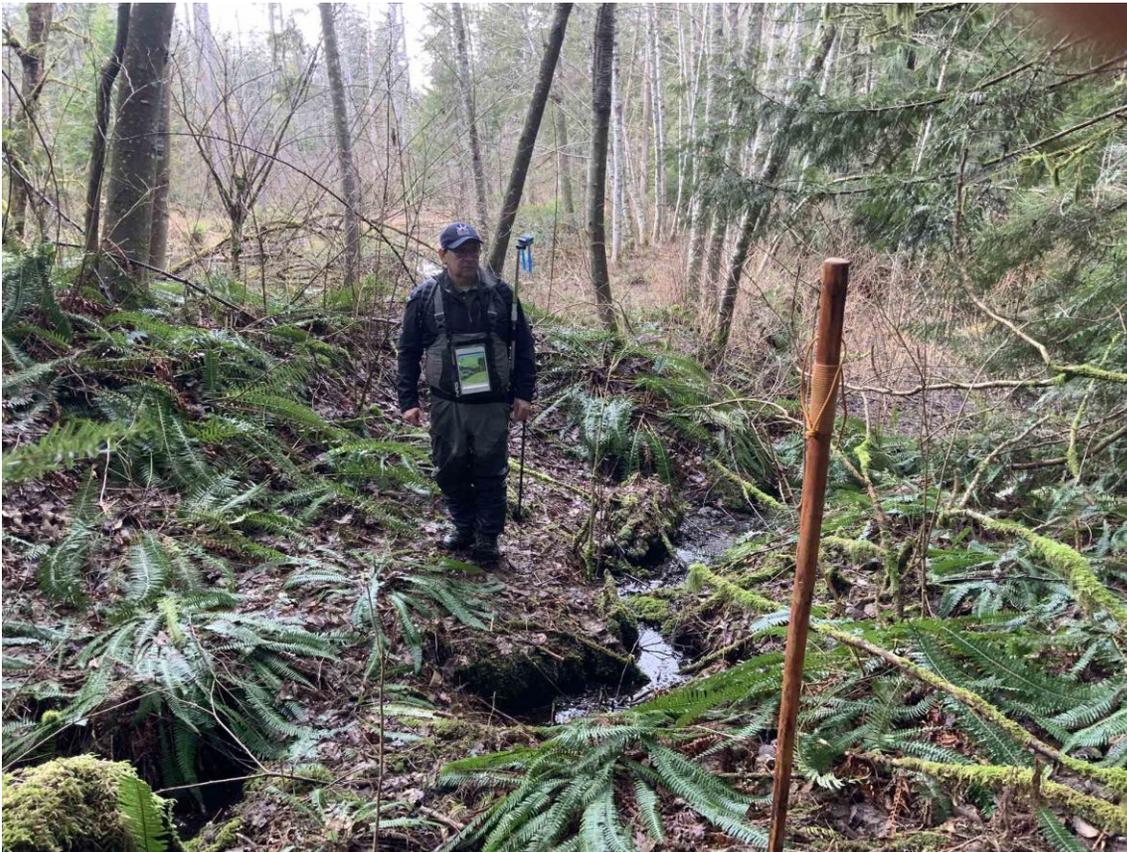
Photo 12: Tracing one of hundreds of small feeder channels in Morrison Headwaters. These channels collect flow from seepage areas, directing it to wetlands or the beginnings of tributaries.

The Mapping and Hydrology projects were closely tied. We traced each tributary to its ultimate sources and mapped our findings. In many cases the source was a maze of smaller and smaller channels (**Photo 11**), many as small as 0.2m, mostly ending in seepage areas near the base of the escarpment. This appears to be the source of Morrison Creeks excellent base flow regime.
